**CLIENT & INSPECTION INFORMATION**

DATE OF INSPECTION: 9.1.2005.  
TIME OF INSPECTION: 8:00 AM

INSPECTOR: Jeff Herboldshimer - Certified Inspector.  
CLIENT'S OFFICE: Century 21.  
DISCLAIMER: This is a computer generated report with information entered by a human being. It is possible there have been accidental entries from mistaken keystrokes. If these unintentional entries make it past editing, notify me for a corrected report.  
CLIENT'S AGENT: Melisa Sorensen.

**Associated Inspection Services:** Human, Harold, Gridley, 215 Hazel,  
maintenance is required to obtain maximum service and durability.

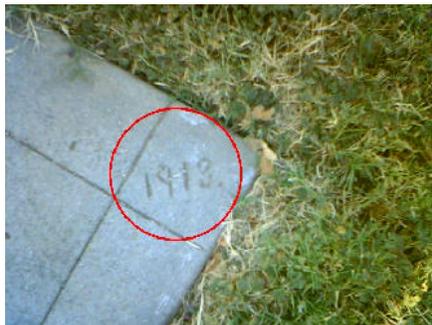
DRIVEWAY: Acceptable. Concrete. There are cracks that appear typical for a house of this age. We recommend sealing any cracks in the driveway slabs to prevent further water intrusion.  
DRIVEWAY  
DRAINAGE: Good.  
WALKWAYS:

Concrete. There are cracks that appear typical for a house of this age. We recommend sealing any cracks in the walkway slabs to prevent further water intrusion. Installed in 1913.

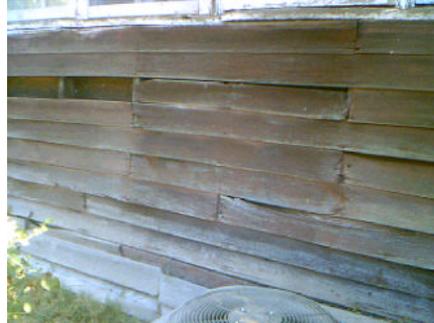
SIDING  
CONDITION:

All horizontal trim should be regularly maintained to prevent water infiltration and material deterioration. This usually includes caulking and painting. Paint is no longer providing the protection needed.

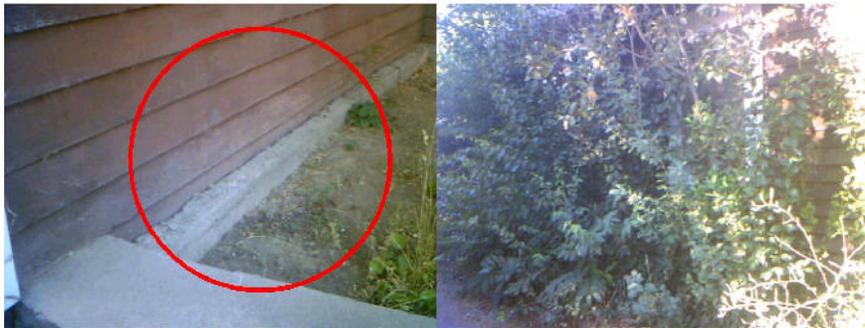
OTHER  
CONDITIONS:

Vegetation limits access to the exterior surfaces. Earth to wood clearance is: Poor at: all areas where concrete is poured over wood members.

Wood/earth contact noted. Non treated wood is not insect resistant and may encourage infiltration.

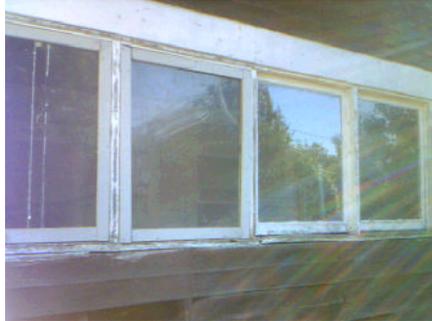
TRIM PAINT  
CONDITION: Poor.  
EAVES/  
OVERHANGS  
CONDITION: Poor.  
WINDOWS  
CONDITION:

Poor. Material deterioration noted.

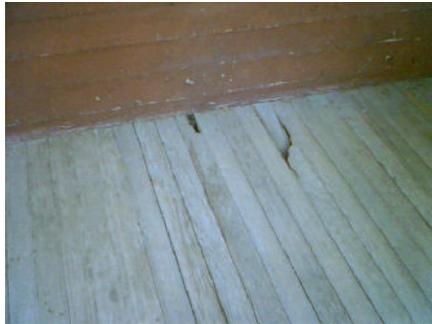
**FRONT PORCH**  
TYPE:

Wood-General condition is fair, some areas need repair.

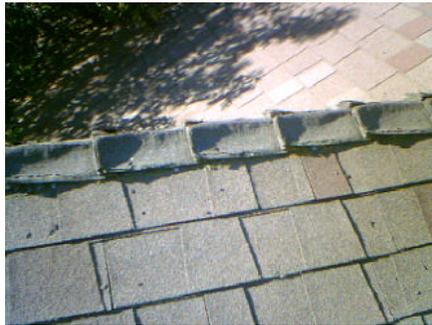
RIDGES:

Pieces of the ridgecap are deteriorated, It has been my observation the high profile ridge cap that has been installed deteriorates at a rate faster than the field materials. Depending on conditions, the ridge might need to be replaced after 10-15 years. Repair/replace as needed.

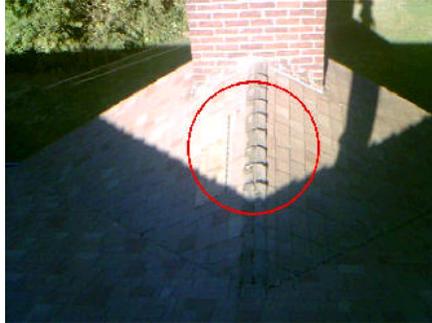
Some of the shingles showed the following conditions: missing shingles, some have been patched.

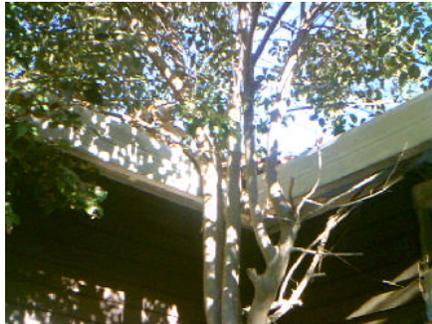
General condition is Fair, The rain gutters are in need of cleaning. Damaged from tree. Paint is no longer providing the desired protection in some areas. Minor damage to downspout noted.

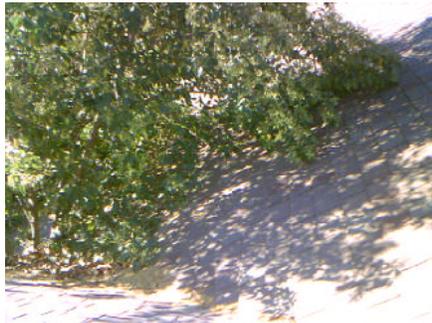
**FACIA AND TRIM**  
**DOWNSPOUTS:**  
**VEGETATION:**

Vegetation overhangs the roof = Recommend trimming as needed.

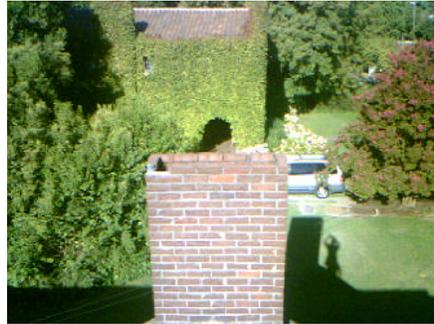
The chimney crown is deteriorated and needs to be repaired to prevent further damage to chimney.

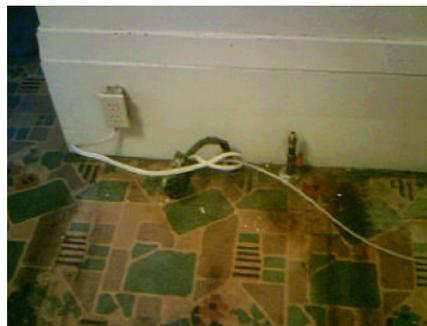
Gas line is not capped, electric outlet is not secure or protected by conduit. A licensed contractor, experienced in this field, should further evaluate this condition. Bootleg 110 volt circuit has been taken from 220 volt outlet. 110 volt outlet is not properly protected by circuit breaker. ***THIS IS A HEALTH/SAFETY CONCERN.***

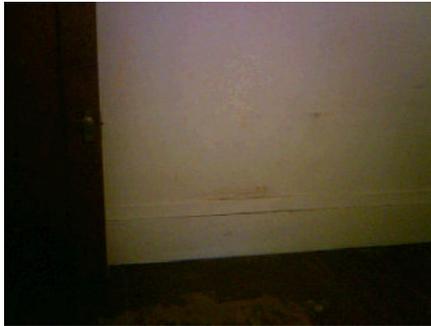
WALL FINISH:

Wall damage noticed, possible water damage from shower.

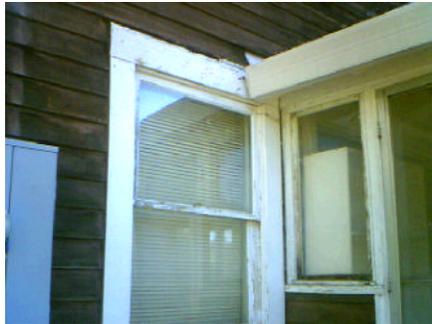
MATERIAL:

Windows are old and have not been maintained. Some have material deterioration. Paint is no longer providing protection.

CONDITION: Poor, Some of the window rollers/guides are worn and do not function smoothly.  
FUNCTION: Many of the balancers have damaged ropes.

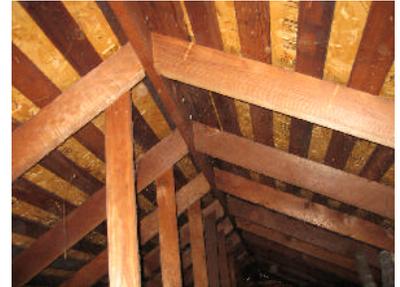
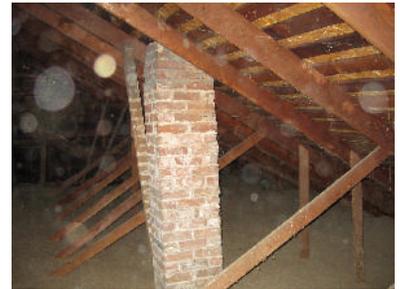
TRUSS SYSTEM: Yes.  
REMARKS: There are two abandoned chimneys noted. This is an observation for your information and not considered a negative condition.

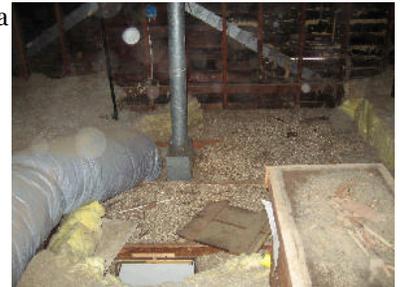
ATTIC INSULATION: Type: Fiberglass Batts. Total Thickness: r-19+. Area over laundry and back porch lack adequate insulation. A licensed contractor, experienced in this field, should further evaluate this condition.

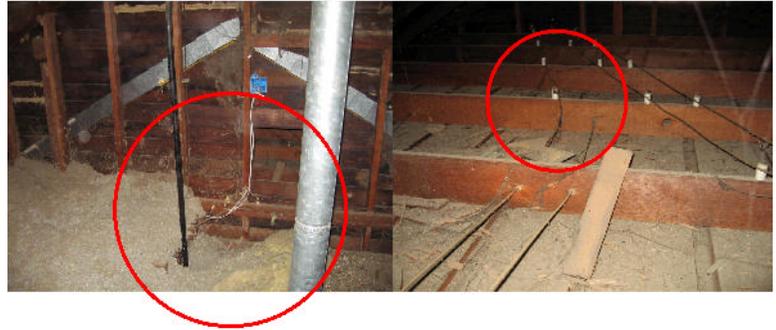
ATTIC  
ELECTRICAL:

I observed splicing of modern wiring to the old knob & tube that does not conform with modern splicing guidelines = Recommend further evaluation/repair by a licensed Electrician. Noted line splices in the attic without the use of proper J-boxes and covers = Repair. Knob & Tube wiring is covered with insulation = This may present a Fire hazard. A licensed contractor, experienced in this field, should further evaluate this condition.

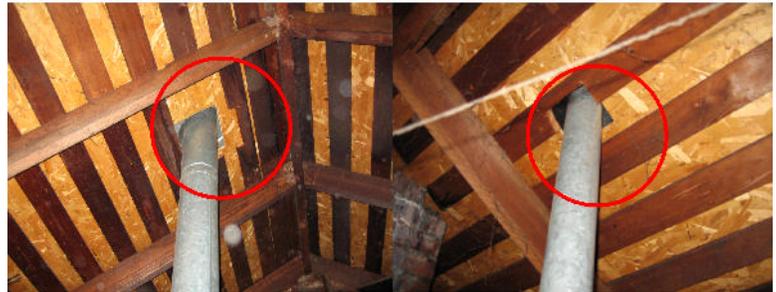
EQUIPMENT  
VENTING

Clearance to combustable materials does not meet manufactures recommendations. 6" clearance to single wall and 2" clearance to double wall is common. Both the furnace and water heater.

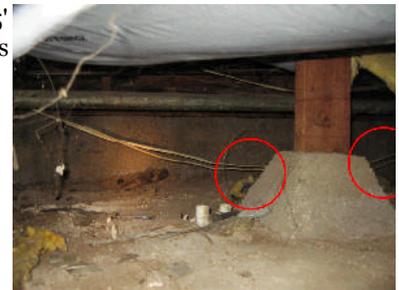
One or more of the wires are not secured every 4'-5' as is common practice. In some instances the wires are in contact with the ground.

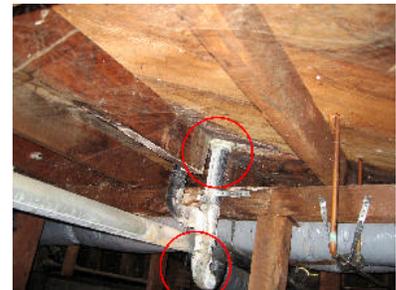
**WASTE PIPE LEAKS:** Evidence of waste pipe leaks at Shower. Please refer to you pest and wood destroying organism report concerning this item. A licensed contractor, experienced in this field, should further evaluate this condition.

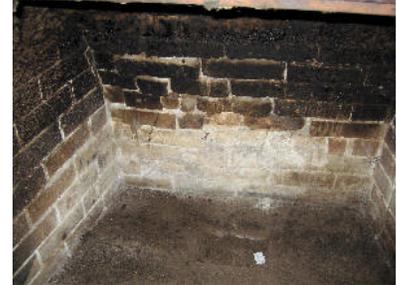
LOCATION: Living Room.  
OVERALL CONDITION: Repairs are needed to restore the integrity to the unit. It is recommended that a Chimney Sweep further evaluate and determine the extent of needed repairs.  
TYPE OF FUEL: The unit is wood burning.  
FIREBOX CONDITION: General condition is Poor. Repairs are needed to the rear wall firebrick. The mortar is deteriorated and the brick are sagging. This makes it unsafe to burn fires until repairs are completed.

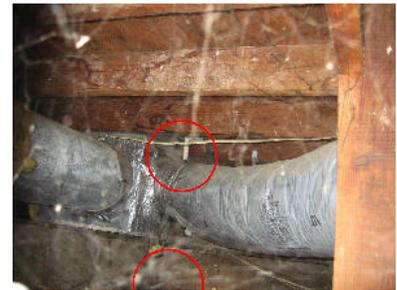
EVAPORATOR DRAIN LINE: The condensate line terminates under the house and water is being discharged. The moisture can lead to material deterioration and biological growth. Current practice is to terminate at the exterior.

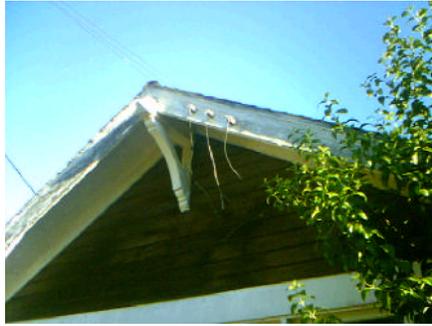
Overhead wires to garage are not functional.

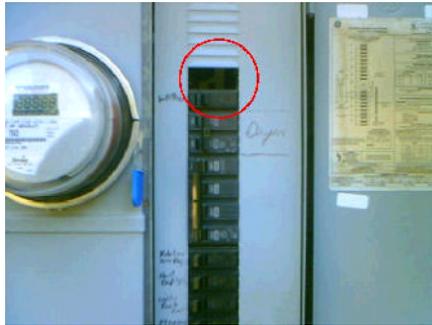
There is an opening in the dead front panel. This space should be filled.
